STS-103 FLIGHT READINESS REVIEW

Presenter:
	Organization/Date: Orbiter/11-19-99

November 19, 1999

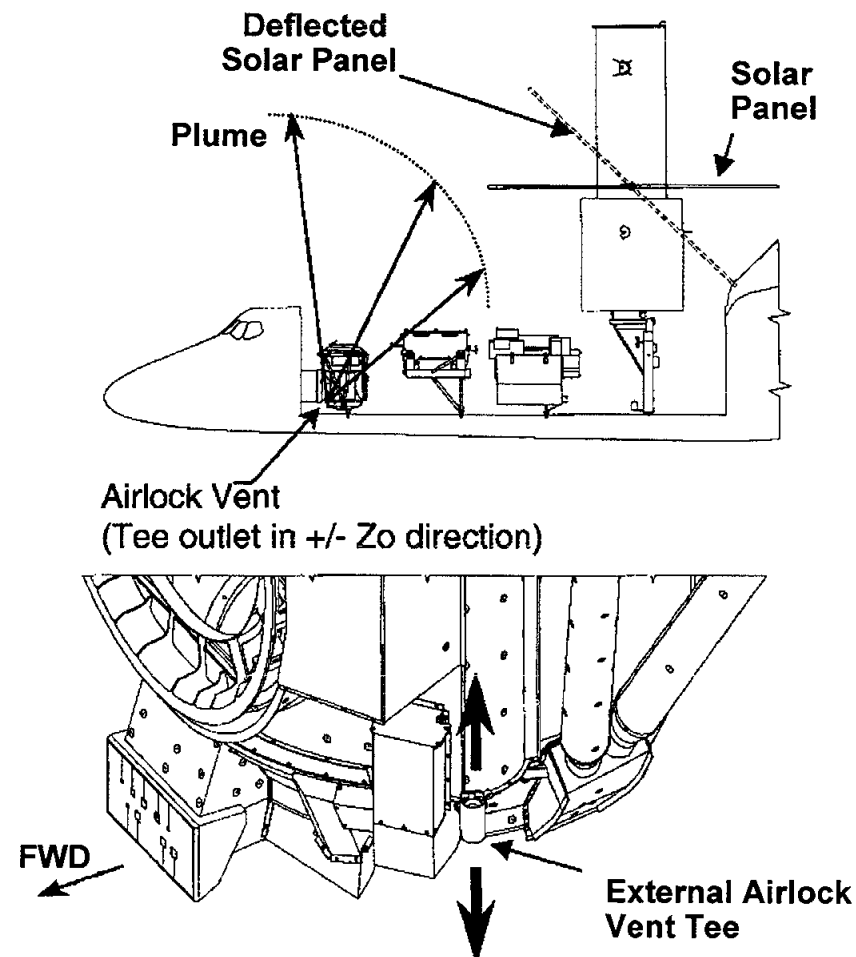
## ODS Venting During STS-82 (HST-SM2) First EVA Airlock Depress Caused Unexpected Movement of the HST -Yo Solar Array

- Documented in payload IFA No. STS-82-PLD-01
- Used position 0 (full open) of the depress valve

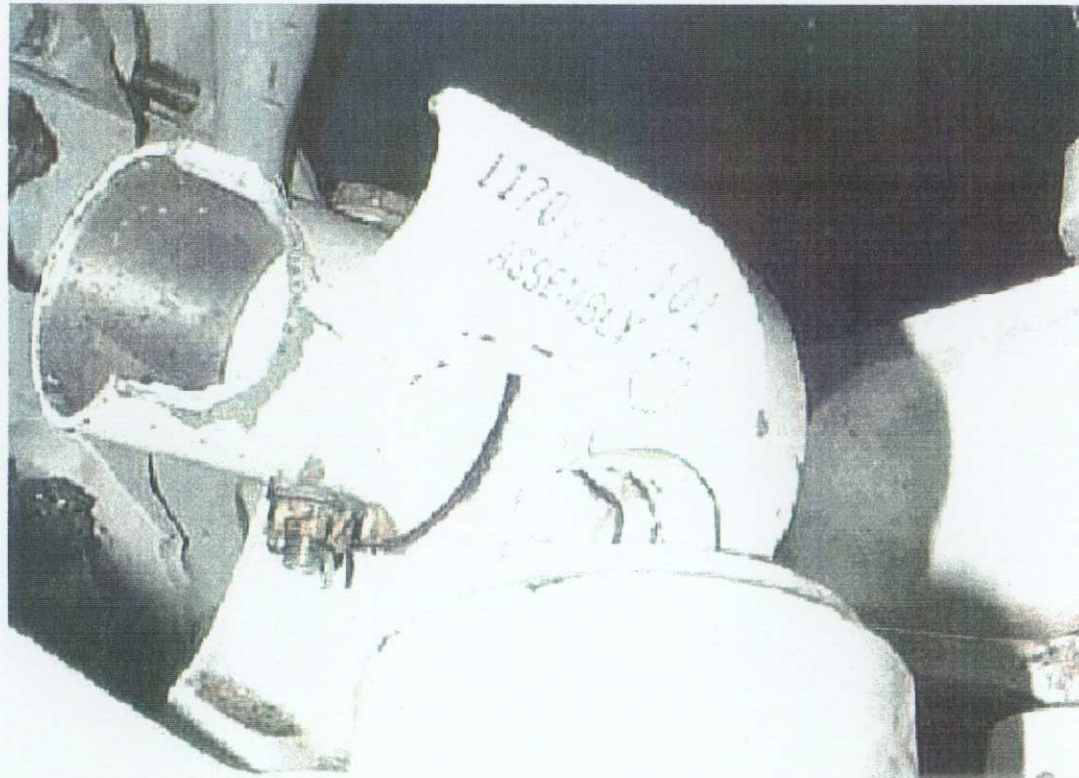
- OV-101 Nose Landing Gear (NLG) lockbrace bungee crank failed near upper attach fitting during gear cycle 2424 of certification extension test series
- During bungee crank investigation, bungee assy found to be not per print and damaged

**Failed NLG Lockbrace Bungee Crank**

- Bungee crank sent to NASA/JSC metallurgical lab for failure analysis
  - Multiple initiation sites were found along the ID surface of the tube
    - Fatigue was not initiated at a pre-existing flaw
  - The primary initiation site was at the ID, outboard corner of the tube (vehicle orientation)
  - Striations found were consistent with the gear deployment cycles
  - Conductivity measurements are consistent with 7075-T7 aluminum alloy
  - Hardness measurements verified T73 heat treatment
  - Failure of the crank tube was initiated in fatigue, followed by a fast fracture, overload surface

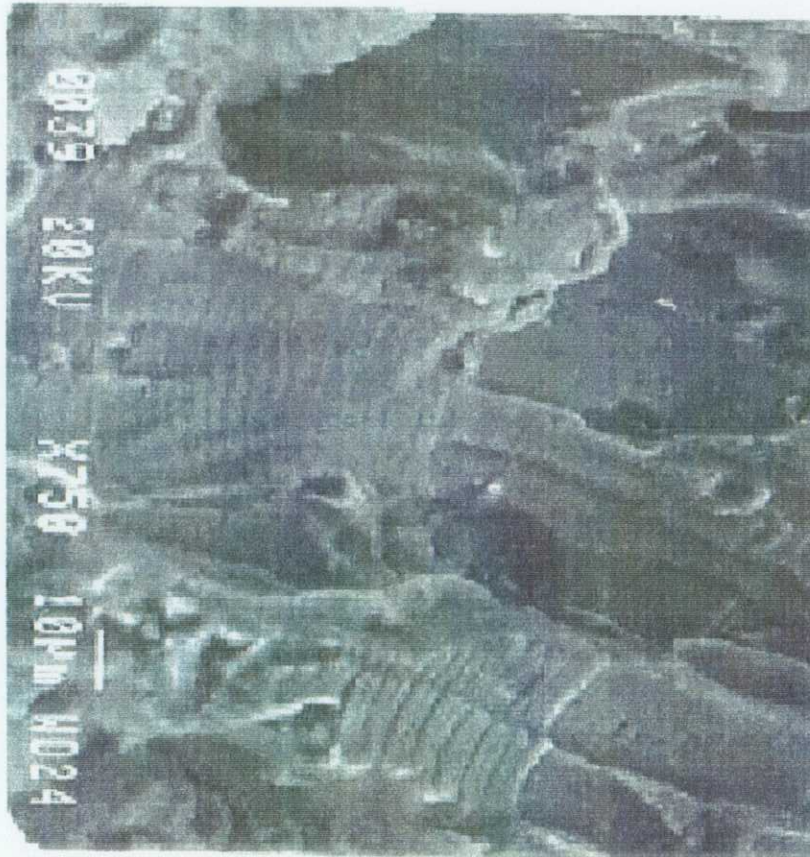
**NLG Bungee Crank Typical Fatigue Striations**

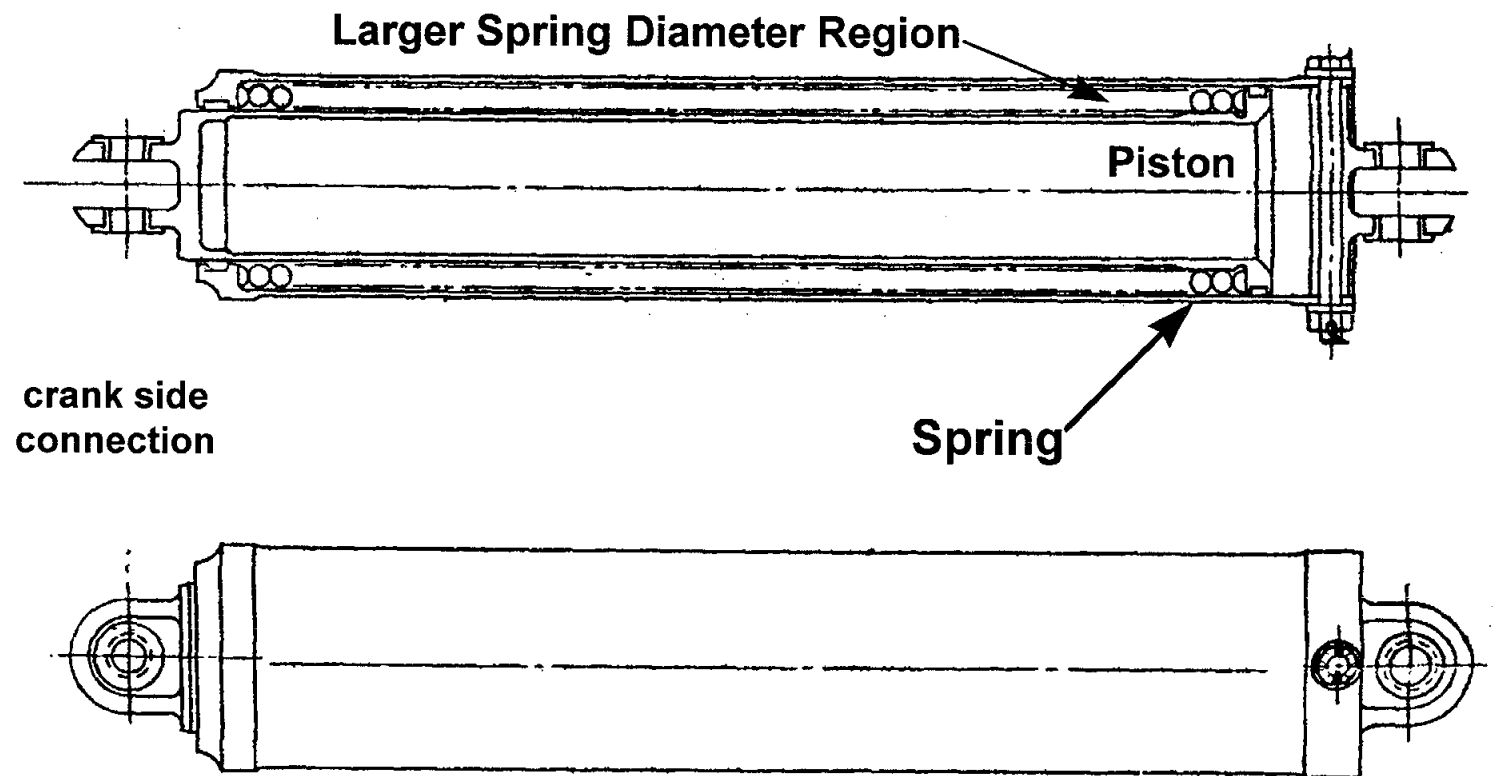
## Cross Section Of NLG Bungee

- NLG downlock bungee failure analysis at B.F. Goodrich Landing Gear Co.
  - Spring measured to be larger than diameter of cylinder bore
    - Measured to be .011" interference and should have been .038" clearance only at piston end of spring
  - Spring surface has significant dry film wear
  - Spring surface had been flattened
  - Bore of cylinder was within drawing requirements
  - Bungee cylinder ID has significant dry film wear
  - Black powder found inside cylinder determined to be worn off loose dry film and spring/cylinder material
  - Bungee failure analysis indicates that dry film wear on spring and housing and oversized spring caused higher load output
- MLG bungee suspect due to similar design

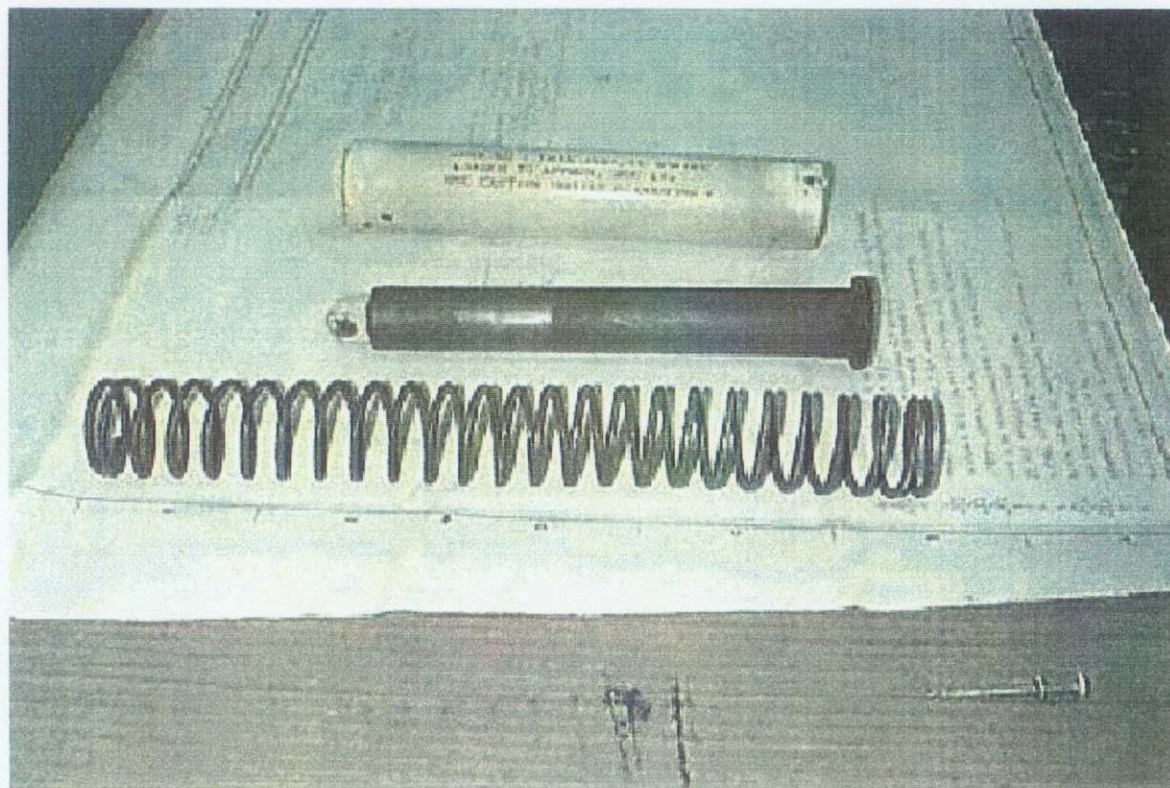
**Disassembled OV-101 NLG Lockbrace Bungee**

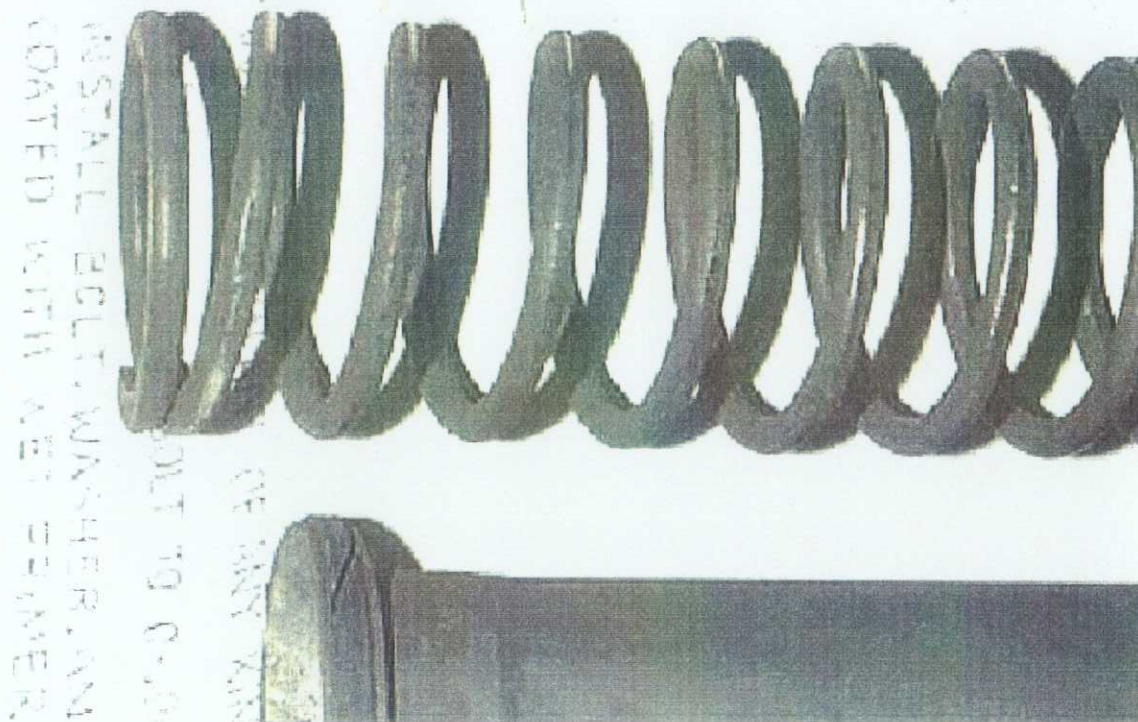
- Bungee failure analysis indicates that dry film wear on spring and housing and over size spring caused higher load output
- Successful inspection of bungee system weak links verified overload condition is not present
  - NLG bell crank eddy current
  - MLG lower attachment cross bolt hole measurement
- Final gear functional in OPF demonstrated proper operation

**OV-101 NLG Bungee Spring With Dry Film Wear**

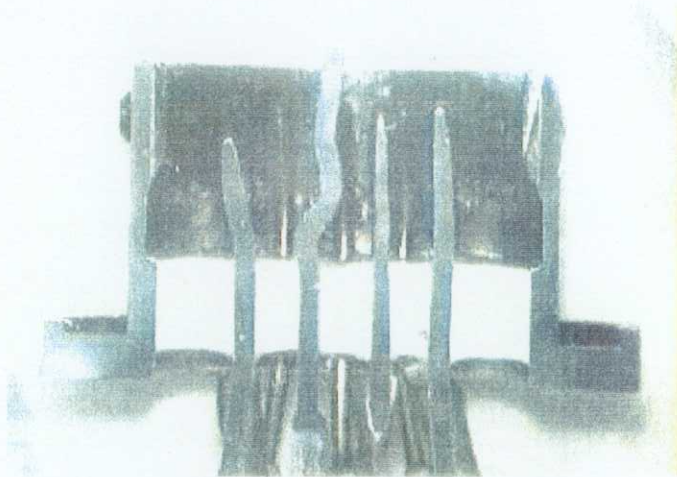
**Cross Section of  
Electrical Connector/  
Glass Hermetic Seal**

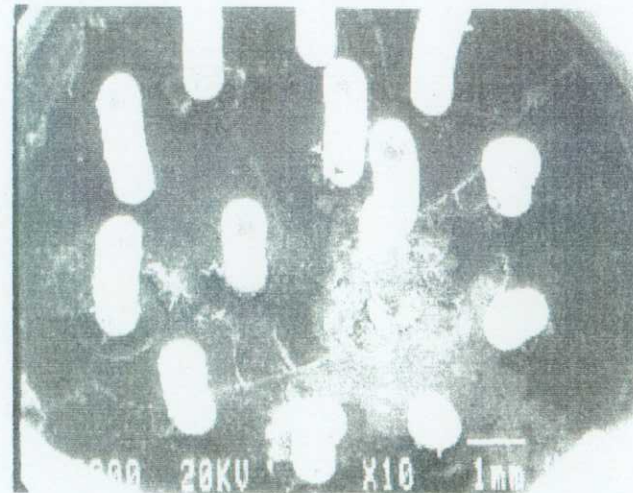
- RCS oxidizer manifold 5 isolation valve (S/N 025) on OV-103, RP03, valve position indicated CLOSED when commanded OPEN
  - Corrosion of the electrical connector was found with a steady reading of 1.0 ppm oxidizer at the connector
- OMS vapor isolation valve PR reported on LV506 on RP03 prior to STS-70 - valve position indicated OPEN when commanded CLOSE
  - UA reoccurred during STS-103 flow

**SEM Photograph of  
Crack in Seal  
Around Bent Pin**

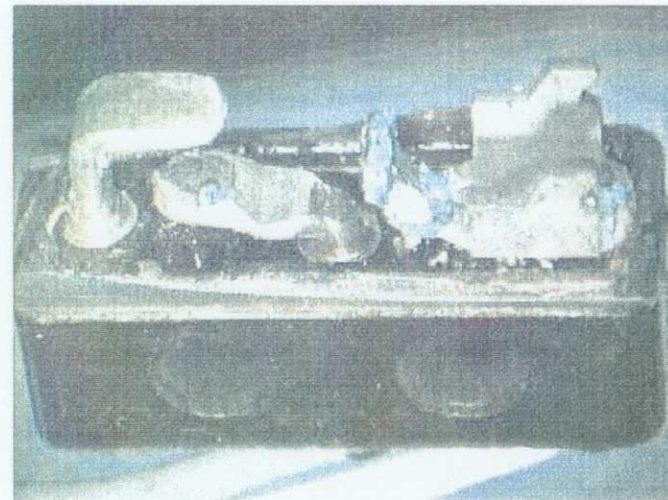
**Switch Spring  
Mechanism Broke  
Off Due to Corrosion**

- Failed ox manifold isolation valve has been removed and replaced
  - Replacement valve has passed OMRSD retest requirements
  - All OV-103 manifold 5 isolation valves have been inspected visually and with sniff checks and no anomalies were noted
    - External leakage through the valve is an inspectable condition
- Intergranular corrosion with AM355 is a very slow process
  - Valve exposed to oxidizer for 15 years
- Oxidizer leakage into valve first manifests itself as VPI problem
  - Initial indication of problem occurred two years ago as intermittent VPI
  - No effect on valve function
- Subsystem redundancy and flight rules exist for worst-case failed open/close manifold 5 valve and vapor isolation valve
- No concern with intergranular corrosion in the fuel manifold 5 valve
- No concern with RCS vernier thruster valve

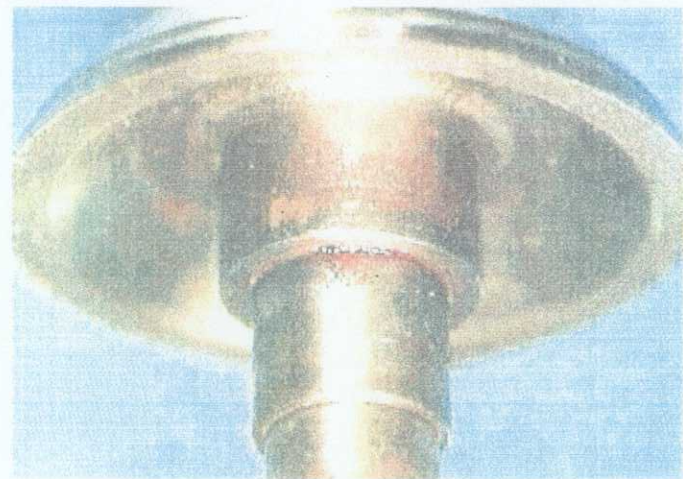
**External Contamination  
on Poppet**

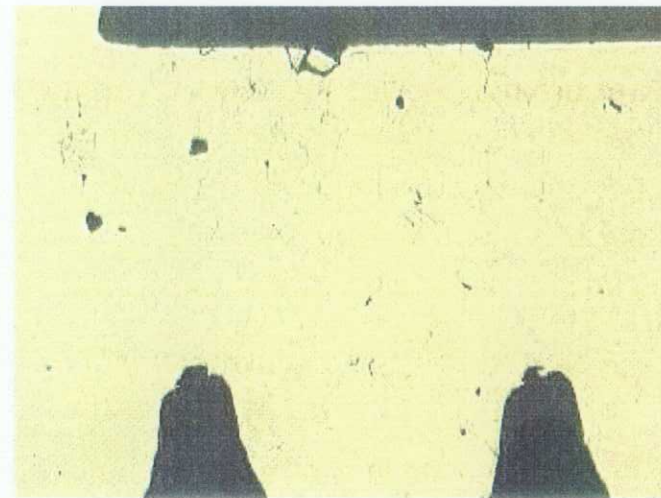
**Poppet Grain Boundaries**

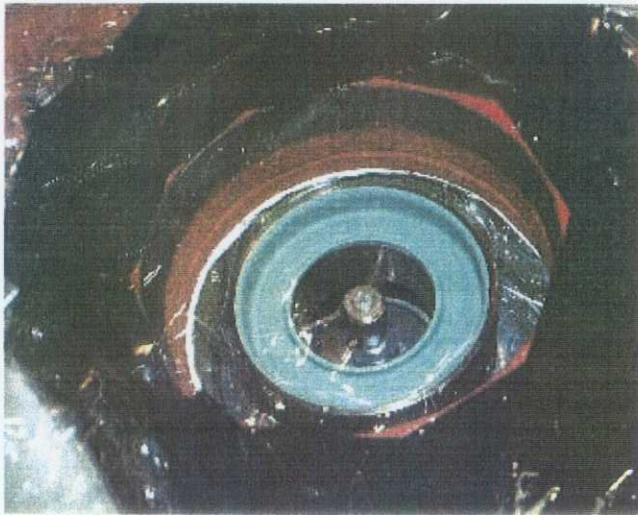
Failed open disconnect

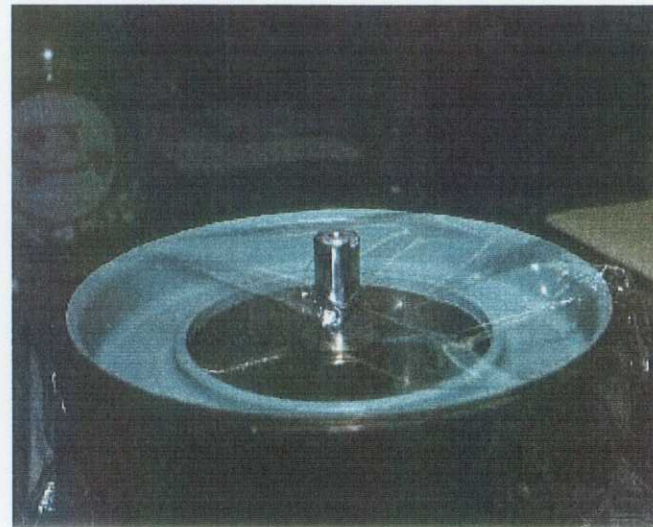
Closed disconnect showing  
poppet stem damage

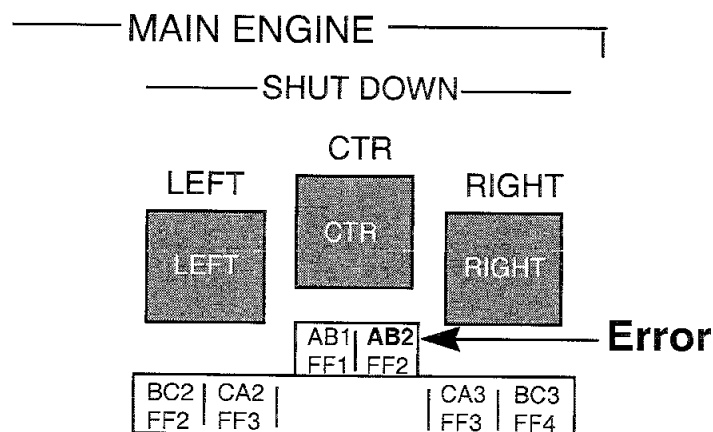
- Supplemental crew preference decal for Main Engine Shutdown switch on Panel C3 was found to be in error
  - Was misidentified with Control Bus AB2, should have been BC1
- Subsequent review of all 253 crew preference decal drawings revealed 3 additional errors
  - Panel O7 LH RCS XFEED 3/4/5 (sw 33)
    - Decal indicates AC2, should be AC1
  - Panel L1 RAD BPV MODE (sw 35)
    - Decal indicates MNB, should be MNC
  - Panel L1 RAD BPV MODE (sw 36)
    - Decal indicates MNC, should be MNB

### INCORRECT MARKING (OV-102 & SUBS)

- Concern (2)
  - Determined that decal installation drawings were incorrect for 4 of 253 drawings
  - Traced all 4 drawing errors to original release (1983)
    - Most probable cause was human error
  - Issued engineering to correct decals
  - Inspection to confirm that all installed labels are correct is in-work
- Decal drawings were only verified by inspection (not test)
  - Action in-work to establish a system to “test” labels as part of the installation process

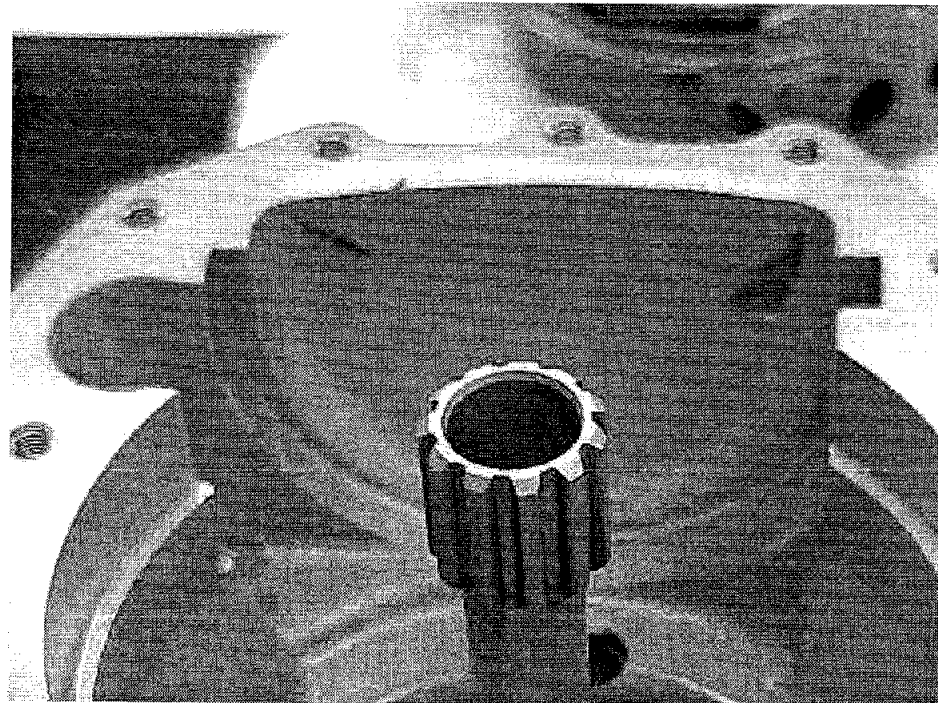
**Damage on Mounting Flange Housing**

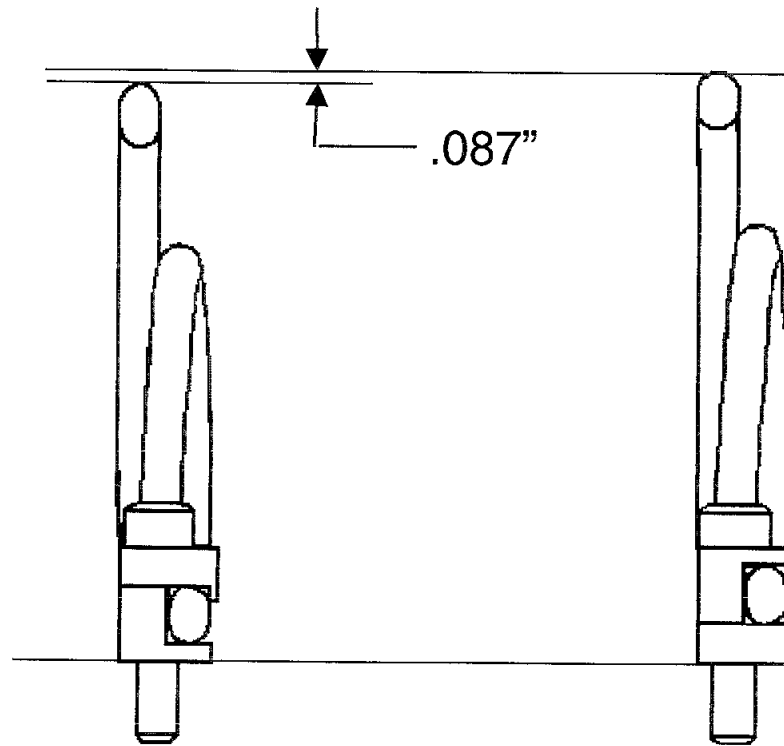
- ABEX indicated that both installation techniques result in identical pump performance

Retainer installation  
of the subject pump
